Review Article

Magnetic resonance imaging in post-operative hip: Navigating the “Forbidden” landscape

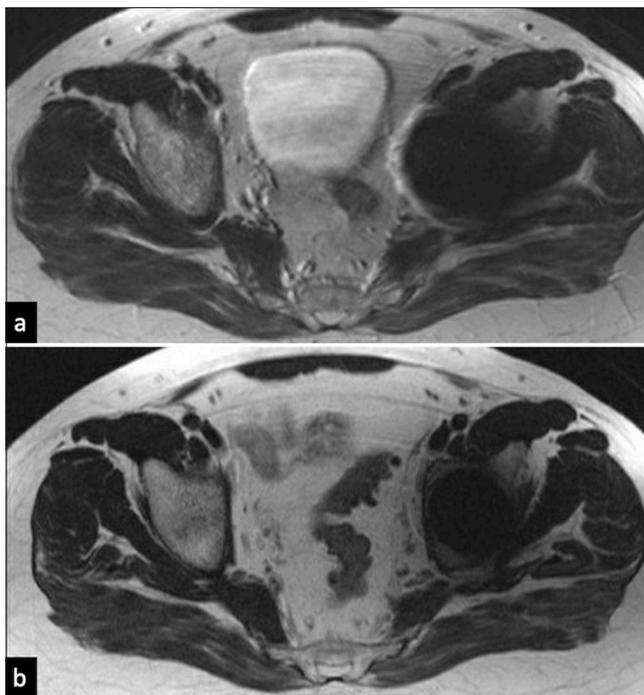
Figure 1: MRI without and with metal artefact reduction sequence (MARS). (a) Axial T2 image without MARS: metallic artifact causing marked hypointensity around the prosthesis causing obscuration of the left hip joint and the adjacent soft tissue, (b) Axial T2 MARS MRI (showing improved visualization of the acetabulum as well as the surrounding soft tissue).

Figure 1 demonstrates how conventional MRI is limited by significant metal artifacts from prosthetic components, which obscure anatomical details. In contrast, MARS MRI provides enhanced visualization of the acetabulum and surrounding soft tissues by minimizing these artifacts, allowing for better clinical assessment of periprosthetic structures. Various MRI vendors offer different specialized MARS techniques, few examples are provided below.

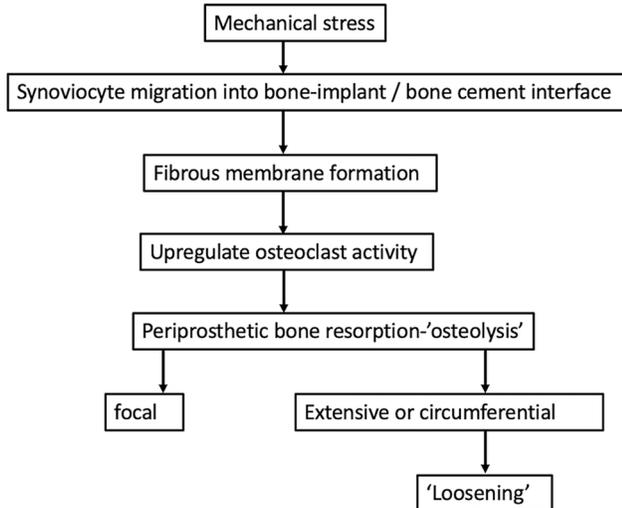
Figure 2: Flowchart showing the pathogenesis of osteolysis and loosening.

Periprosthetic osteolysis begins with wear-induced inflammation, where implant debris triggers an immune response that disrupts normal bone homeostasis, leading to bone resorption [Figure 2]. While normal osseous integration shows direct contact between the implant and surrounding bone, pathological changes manifest as abnormal signal intensity patterns on MRI [Figure 3]. The condition poses a diagnostic challenge as patients often remain asymptomatic

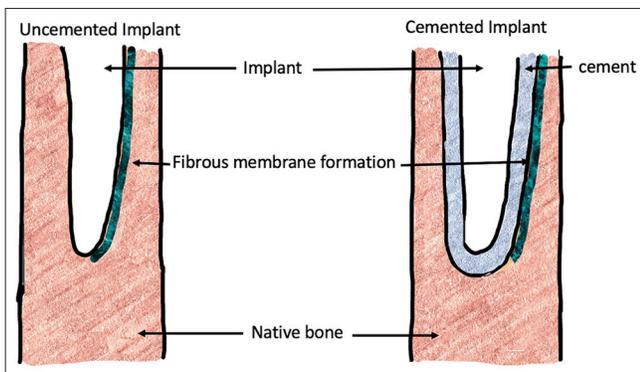
Figure 3: Periprosthetic bone resorption: Schematic showing fibrous membrane formation at the implant bone interface and cement bone interface in uncemented and cemented implants.

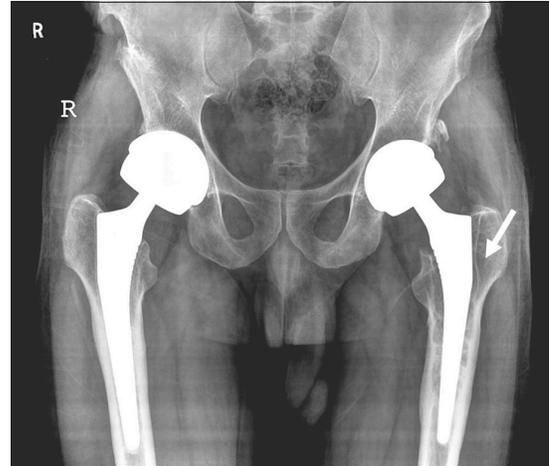
Figure 4: Osteolysis. Plain radiograph of the pelvis with both hips, showing linear lucency (white arrow) at the bone prosthesis interface of the left femur.

despite significant bone loss. MRI has emerged as the most sensitive imaging modality for detecting and quantifying osteolysis, surpassing both conventional radiographs and CT.^[11] On MRI, osteolysis appears as well-defined areas of intermediate signal intensity surrounded by a characteristic low-signal rim, contrasting with the high signal of normal marrow fat [Figures 4 and 5]. This pattern helps differentiate osteolysis from infection or tumoral involvement. Implant “loosening,” as a term should be used when there is extensive or circumferential bone resorption, especially when accompanied by implant displacement or rotation. Serial MRI examinations allow quantitative monitoring of osteolysis progression, with fibrous membrane formation indicated by 1–2 mm hyperintense signal thickness and bone resorption suggested by irregular areas exceeding 2 mm^[12] [Figures 6 and 7].

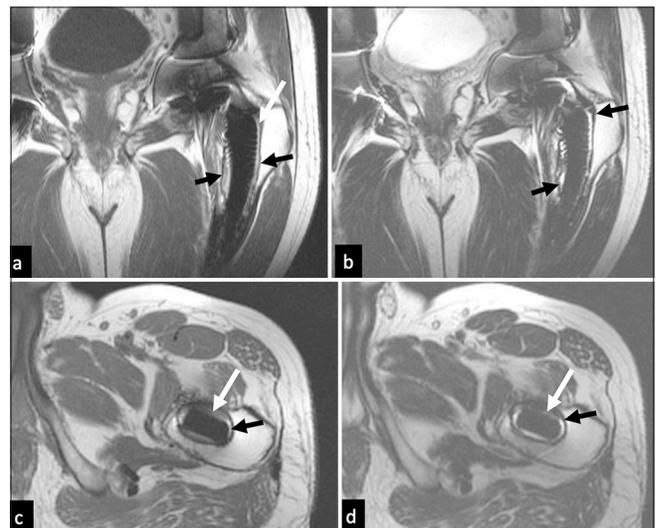
Figure 5: Osteolysis. MRI (a) Coronal T1, (b) T2, (c) axial T1, and (d) T2 images show circumferential intermediate signal (white arrows in a-d) surrounded by a characteristic low-signal rim (black arrows in a-d) at the bone prosthesis interface encasing the stem of the prosthesis.

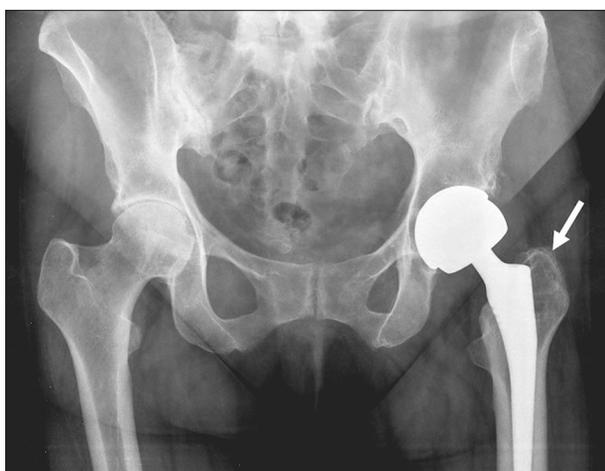
Figure 6: Focal osteolysis. Plain radiographs of the pelvis with both hips show focal osteolysis (white arrow) at the bone prosthesis interface of the left femur

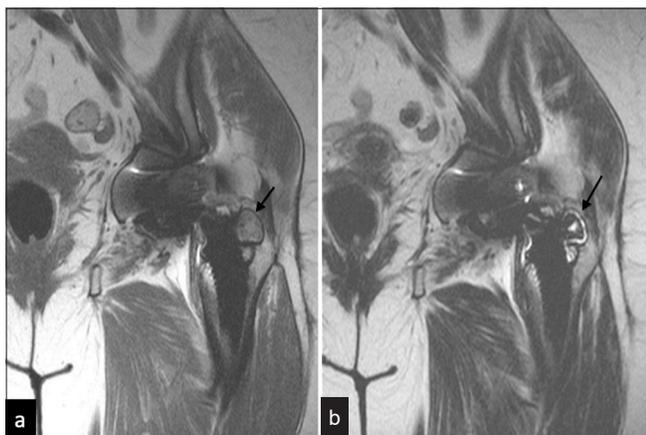
Figure 7: MRI (a) Coronal T1 and (b) T2, images demonstrate well-circumscribed focal lobulated areas of intraosseous increased T2-weighted signal change (black arrow) without any peri-osseous collection consistent with focal osteolysis.

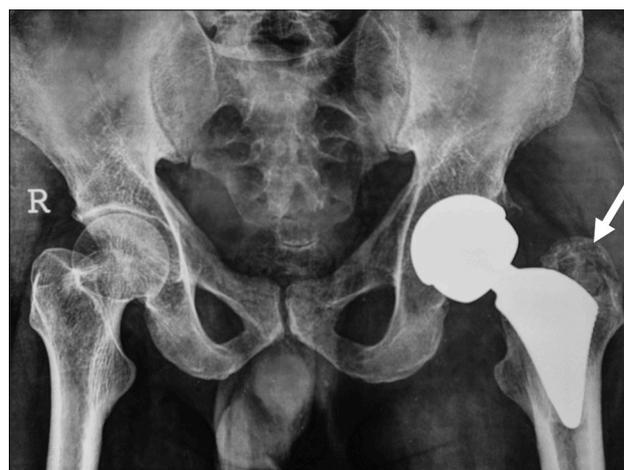
Figure 8: Infection. Plain radiographs of the pelvis with both hips, showing focal osteolysis (white arrow) at the bone prosthesis interface of the left femur with cortical irregularity.

prompt recognition and management to avert complications such as implant failure or systemic infection. MRI demonstrates characteristic features that parallel those seen in other skeletal infections, including enhanced synovial inflammation, fluid accumulation within the joint, and inflammatory changes in the subchondral bone marrow with abnormal enhancement patterns.^[14] Additional findings encompass osseous destruction, osteolysis around the prosthesis, inflammatory reaction of the periosteum, inflammatory changes in surrounding soft tissues, fluid collections with potential cutaneous fistulae, and enlarged regional lymph nodes. A distinctive imaging pattern suggesting infection is the presence of layered thickening of the synovium with increased signal intensity^[7] [Figures 8-10].

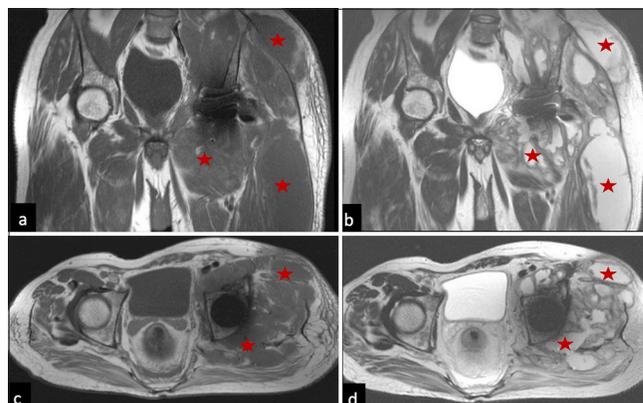
Figure 9: Infection. MRI (a) Coronal T1, (b) T2, (c) axial T1, and (d) T2 images show multiple pockets and a large loculated collection surrounding the left hip (red stars in a-d).

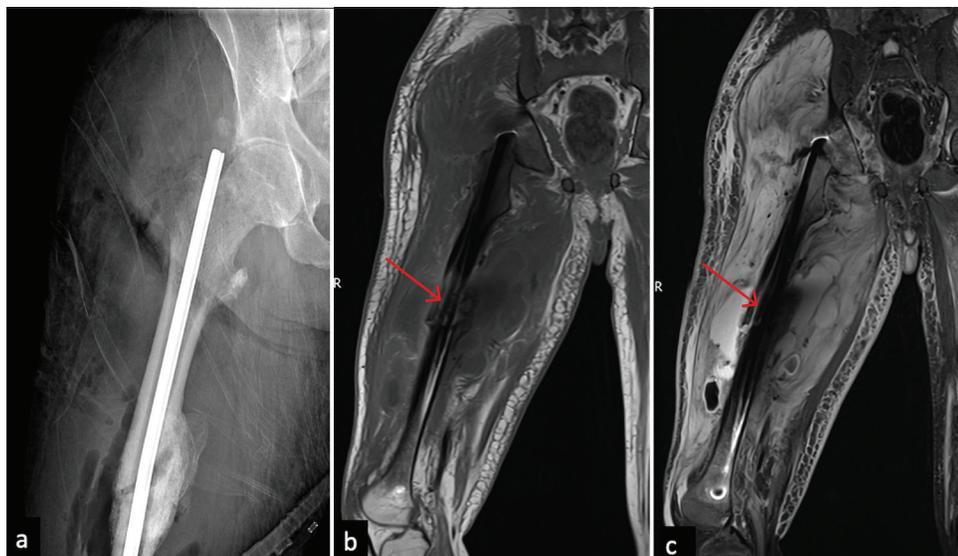
Figure 10: Infection. (a) Radiograph of the right femur showing an intramedullary nail for an oblique shaft fracture showing cortical thickening and solid periosteal reaction in the mid shaft around the fracture site, blurring of surrounding fat planes. (b) MRI Coronal T1 non-FS (Fat Suppressed) and (c) T2 FS reveals intermediate signal along the anterolateral cortex on T1 (red arrow in b) and linear fluid signal just deep to it on T2FS (red arrow in c) which is contiguous with large collection in the periosteal soft tissue with surrounding extensive soft tissue edema. There is associated marrow edema in the proximal femoral shaft and right subchondral location of the right hip joint involvement.

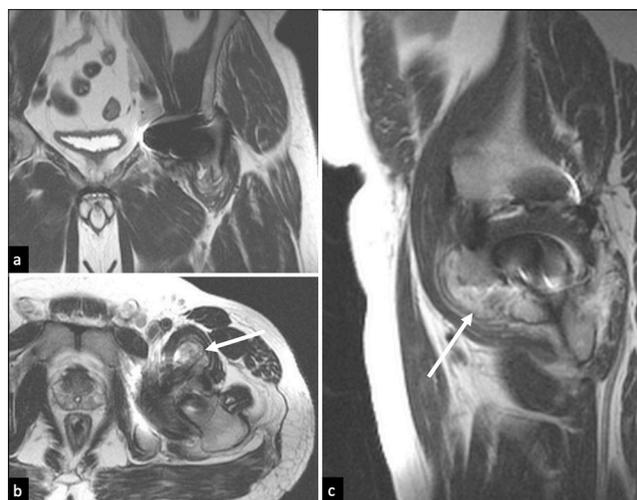
Figure 11: Polyethylene wear induced synovitis. (a) T2 nonfat-saturated Coronal, (b) axial, and (c) sagittal images show pseudo capsule distension with low to intermediate thick-walled synovial lining and heterogeneous intermediate signal intensity debris that has decompressed into the left iliopsoas bursa (white arrows).

particulate synovitis showing low-to-intermediate signal intensity (comparable to muscle signal), interspersed with variable fluid content. In advanced cases, the inflammatory process may extend into surrounding bursae, including the greater trochanteric bursa posteriorly or the iliopsoas and subiliac bursae anteriorly. Due to its similar signal characteristics to muscle, careful evaluation is necessary to detect this extension. Diagnostic considerations include the presence of a polyethylene liner, implant longevity, and distinctive synovitis patterns. Associated osteolysis typically presents as bulky lesions where particulate debris replaces normal periprosthetic bone marrow signal^[7] [Figure 11].

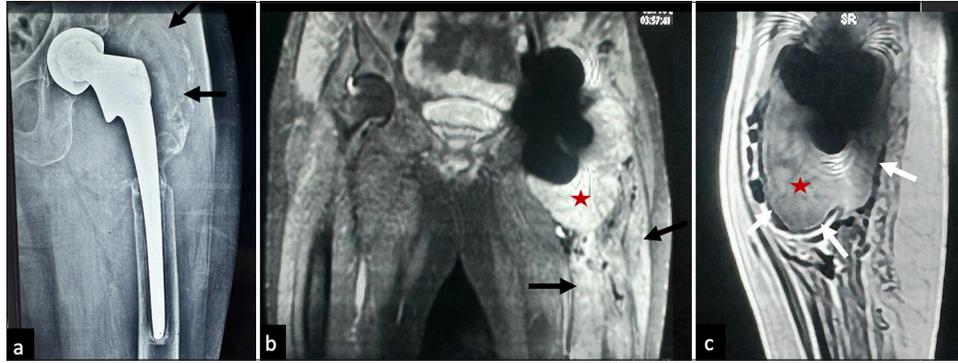
Figure 12: Adverse local tissue reactions caused by hypersensitivity to metal products (ALVAL) (a) Anterior-posterior radiograph left hip joint showing marked osteolysis around the femoral component involving the greater trochanter (black arrows). (b) Coronal STIR and (c) sagittal T2 non fs MR image of the same patient showing marked distension of pseudo capsule with thin hypointense lining (white arrows) and intermediate to hyperintense signal fluid content (red star in b and c), there is marked periprosthetic soft tissue edema in the visualized left proximal left thigh (black arrows in a-c).

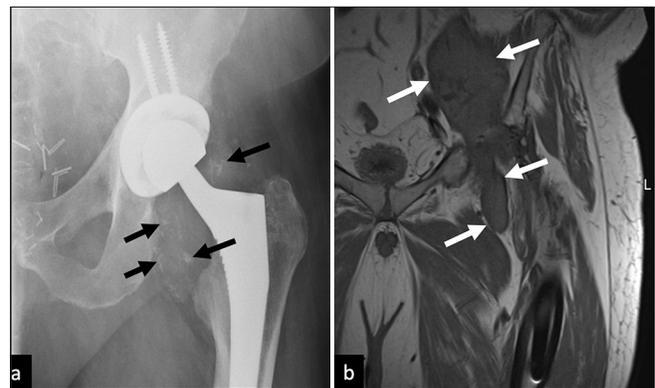
Figure 13: Adverse local tissue reactions caused by hypersensitivity to metal products (ALVAL) in a metal-on-metal hip replacement patient. (a) Plain AP radiograph of the left hip shows metallic debris within the joint capsule (black arrows), and (b) Coronal T1 non FS MRI image demonstrates soft tissue extending along the left iliac and common femoral neurovascular bundle bursa (white arrow) in keeping with ALVAL. FS: Fat saturation, MRI: Magnetic resonance imaging, AP: Anterior-posterior.

ALVAL represents a distinct subset of ALTR characterized by type IV hypersensitivity response to metal ions and corrosion products. The histopathological hallmarks include variable degrees of tissue necrosis and infarction.^[19] MRI typically reveals synovial proliferation and joint distension with hyperintense fluid forming pseudotumors [Figure 12]. Posterior pseudocapsular dehiscence commonly results in fluid decompression into the greater trochanteric bursa, potentially compromising adjacent structures including abductor tendons and sciatic nerve complexes. Anterior decompressions may affect the iliopsoas mechanism and femoral neurovascular structures [Figure 13]. Associated findings include periprosthetic edema and lymphadenopathy.^[16]

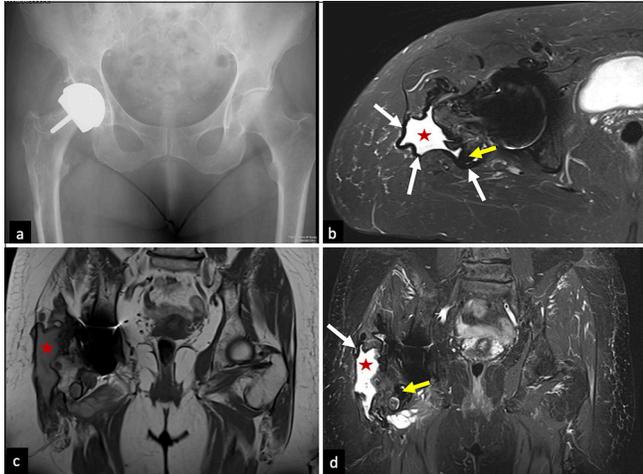
Figure 14: Metallosis: (a) AP pelvis with bilateral hip radiograph of a metal-on-metal right hip resurfacing arthroplasty system. (b) Axial STIR, (c) coronal T1 non FS, and (d) STIR MR images show dehiscence of the posterior pseudo capsule with fluid extending into the trochanteric bursa (red star in b-d), note the markedly hypointense synovial lining (white arrows in b and d) and few hypointense debris (yellow arrows in b and d). FS: Fat saturation, AP: Anteroposterior, STIR: Short tau inversion recovery, MR: Magnetic resonance.

leading to implant failure. Metal accumulation may manifest as susceptibility artifacts within soft-tissue deposits and in the pelvic lymph nodes. While osteolysis can occur in both metallosis and hypersensitivity reactions, it is more characteristic of metallosis. Hypersensitivity reactions typically present with predominant soft-tissue involvement and necrosis. The coexistence of both conditions results in overlapping imaging features^[21] [Figure 14].

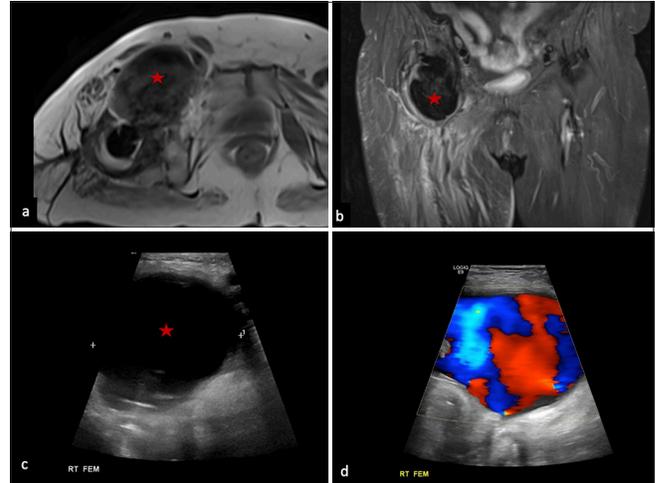
Figure 15: Pseudotumor mimic: (a) T1 non-fs axial and (b) T2 fs coronal MRI in a patient of right total hip arthroplasty showing a large mass-like lesion with T1/T2 hypointense signal anterior to the right hip joint (red star in a and b), based on the MRI findings, a suspicion of pseudotumor formation with hypointense metallic debris within and causing decompression into the iliopsoas bursa can be raised. On ultrasound correlation of the lesion, (c) transverse view greyscale showed a large collection with anechoic internal content with a thin outline (red star), (d) on color doppler image, turbulent flow showing ‘to and fro’ pattern was seen suggesting pseudoaneurysm arising from the right femoral artery.

arterial flow can create flow voids that may be mistaken for pseudotumors containing metallic debris on standard MRI sequences. Such distinctions are crucial for proper patient management and avoiding adverse outcomes and ultrasound correlation becomes crucial [Figure 15].

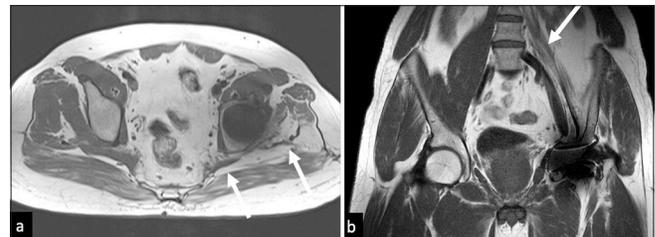
Figure 16: Muscle atrophy. (a) Axial T2W showing severe atrophy of the left Gluteus medius and left piriformis (white arrows) and (b) coronal T1 W image in a different patient showing severe atrophy of the left iliopsoas (white arrow).

Commonly seen in the gluteal group of muscles or piriformis due to altered biomechanics or nerve injury, post-surgery muscle atrophy is often asymptomatic and seen as an incidental finding unrelated to post-arthroplasty pain [Figure 16].

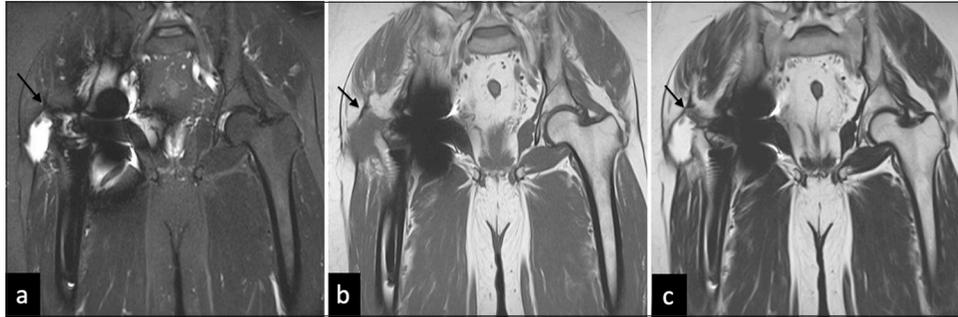
Figure 17: Tendon tear. (a) Coronal STIR, (b) T1W, and (c) T2W images showing avulsion of the right Gluteus medius tendinous insertion from greater tuberosity insertion, with fluid in the trochanteric bursa (black arrows in a-c).

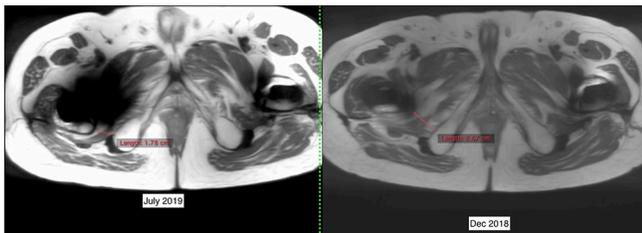
Figure 18: Ischiofemoral Impingement. Axial T2 images obtained a year apart show a narrowing of the ischiofemoral space from December 2018 to July 2019.

This is seen as reduced ischiofemoral distance or the quadratus femoris space and is best seen on axial images [Figure 18]. There are no definite criteria, but ischiofemoral space <1.5 cm with associated edema or atrophy of the quadratus femoris muscle belly should be considered with suspicion for ischiofemoral impingement. In these patients, radiographs are usually normal.^[22]

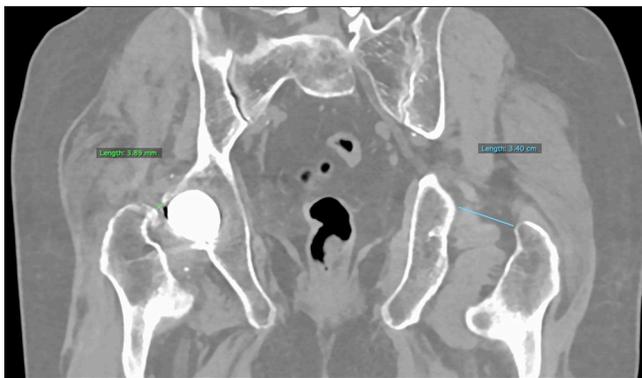
Figure 19: Trochanteric-pelvic impingement. Reconstructed coronal computed tomography images shows decreased trochanteric-acetabulum distance on the right as compared to left – this is consistent with trochanteric pelvic impingement.

It is an extra-articular hip impingement caused between the greater trochanter and the ilium or posterior rim of the acetabulum, often due to loosening or any other structural malalignment [Figure 19].^[23]
