Review Article

Orthopedic hardware in trauma – A guided tour for the radiologist-Associated complications (Part 2)

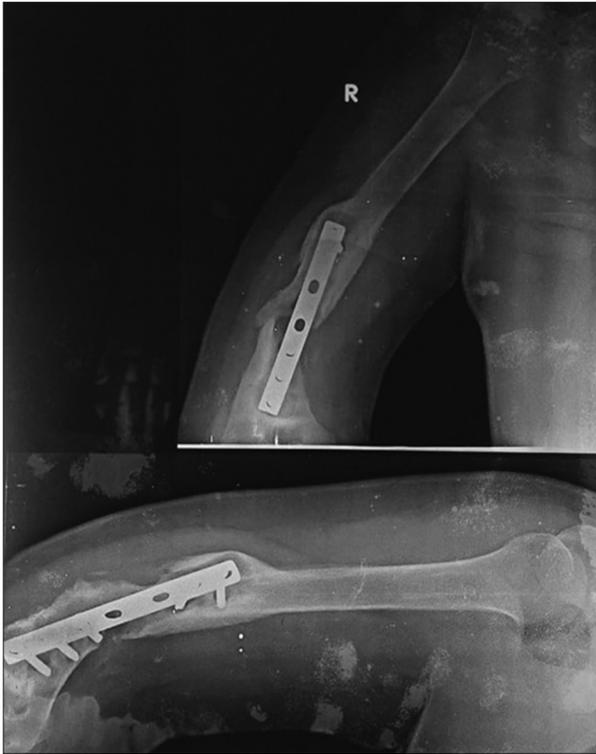
Figure 1: Anterior posterior and lateral radiographs of the right humerus showing nonunion with hypertrophic callus formation. Note the peri-implant lucency is more than 2 mm thick indicating hardware loosening.

Radiographically, it is identified as an abundant callus without bridging of bone and non-united fracture ends. The callus formation suggests adequate vascularity and biology with inadequate stability at the fracture site resulting in non-union [Figure 1].^[5,6]

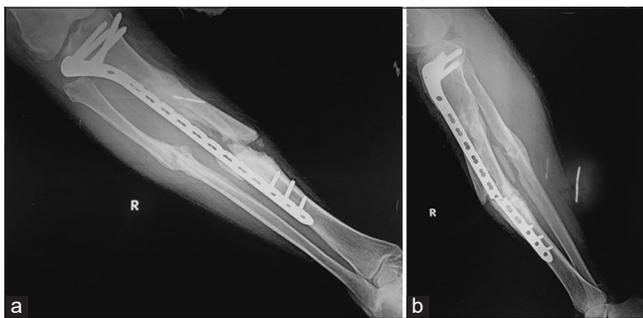
Figure 2: (a) Anterior posterior (AP) and (b) lateral radiograph of the leg showing buttress plate with fixation screws proximally for fracture mid shaft of the tibia, showing atrophic non-union, due to rigid fixation and distraction at the fracture site. Also note implant failure was identified clearly on lateral view only, seen as a faint fracture only on the AP view. It is seen at the screw hole, which is the weakest point in a plate. The soft-tissue density with linear opacity identified on the lateral view is artefactual.

It may be seen in devitalized bone and may be iatrogenic or secondary to soft-tissue injury during the trauma. Due to the lack of blood supply, the fracture ends are osteoporotic and atrophic which are radiographically identified as absent callus formation. Non-weight bearing results in the bone ends being radiographically dense compared to the adjacent viable bone which appears more osteopenic. In radionuclide studies, such fracture sites are “cold” with no uptake. These are commonly seen in tibial fractures treated with plates and screws [Figure 2].^[1,5,7]

Plate fractures usually occur at the screw hole, which is the weakest point [Figures 2 and 11]. Studies also show the lag screw to be the weakest spot.^[10] It is worthwhile recalling that a lag screw is an interfragmentary screw that is used to compress fracture fragments.^[11] This may be a subtle finding, therefore one must look for a step off in the contour. Plate fractures may be identified only on one view, especially if they are parallel in orientation. Hence, it is important to assess the plate in two orthogonal views.

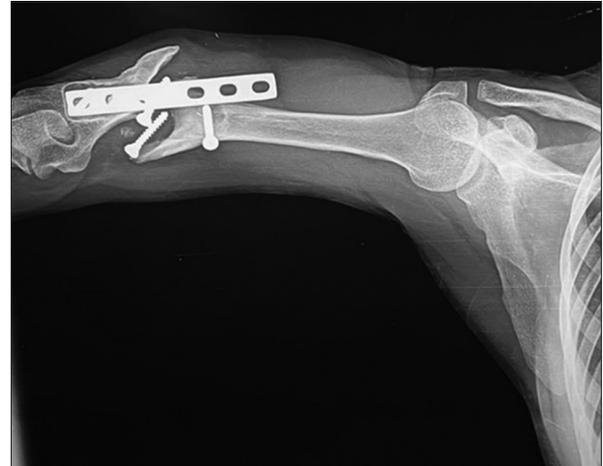
Figure 3: Lateral radiograph of the humerus showing oligotrophic non-union with displaced and migrated screws and plate.

healing process [Figure 3].^[1,5,7] Non-union can lead to other complications as well, for example, Scaphoid Non-union Advanced Collapse with ununited scaphoid fractures.

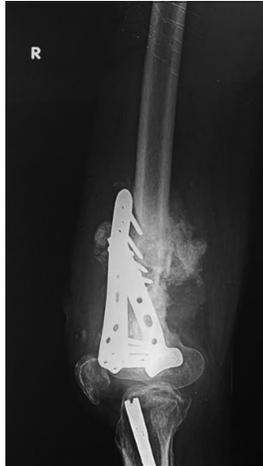
Figure 4: Lateral radiograph of the femur with distal buttress plates and screws showing hypertrophic callus with surrounding soft-tissue densities suggesting infection. An intramedullary nail is also seen in the proximal tibia with surrounding lucency suggestive of loosening.

Loosening is identified as a progressive periprosthetic lucency or “halo” of more than 2 mm. Hence, stating the importance of comparative studies. Progressing lucencies may indicate a failing implant, unstable fixation, or sometimes infection [Figures 4 and 5].

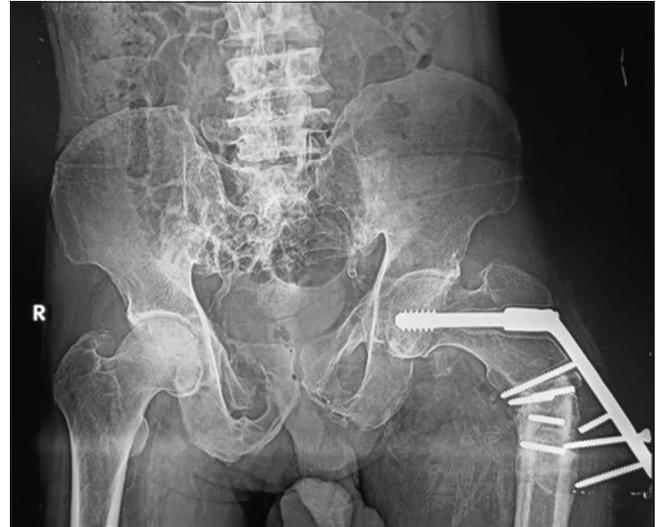
Figure 5: Anterior posterior radiograph of the pelvis showing dynamic hip screw (DHS) *in situ*. Varus deformity of the hip is seen with classical periprosthetic lucency more than 2 mm wide, displaced plate, loosening, and fracture of the screws. This suggests that the patient continued to walk on the varus hip forcing the DHS to come out leading to failure. Also, note background osteoporosis.

Constant motion or abnormal weight bearing may also cause the screws to bend, break, or loosen out. This is often seen when screws are placed near a joint or secondary to abnormal weight bearing leading to a stress-related fracture of the hardware [Figures 5 and 7].

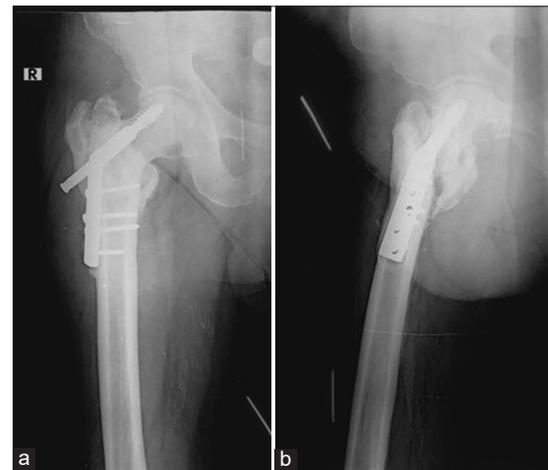
Figure 6: (a) Anterior posterior and (b) Lateral radiographs of the right hip with intertrochanteric fracture status post-dynamic hip screw (DHS) showing superiorly displaced/cut through and backed out DHS screw. Note the prominent periprosthetic lucencies around the screw in the head on the lateral view only and the associated non-union.

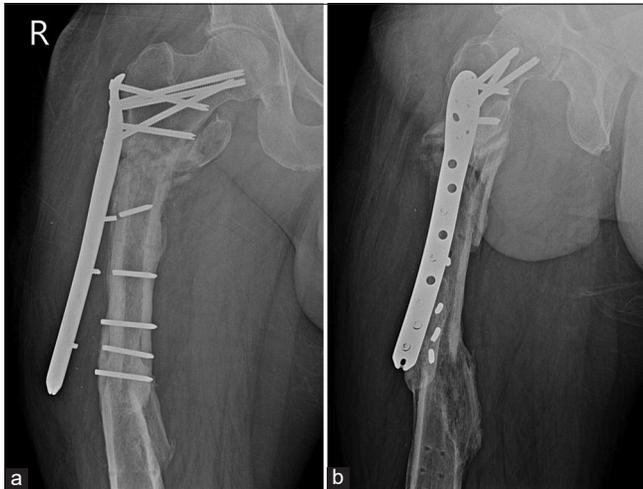
Figure 7: (a) Anterior posterior and (b) Lateral radiographs of the right thigh showing plate and screw failure secondary to nonunion of subtrochanteric fracture with loss of contact of the compression plate from the shaft. Old, healed, fracture shaft of the femur is seen with tracks from previous implants.

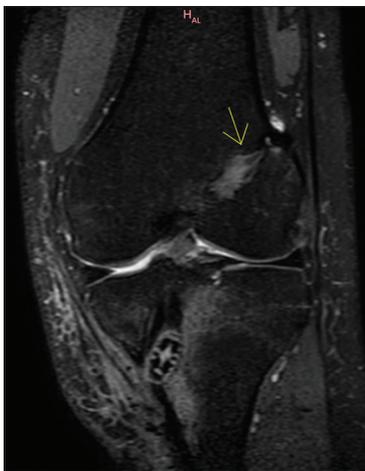
Figure 8: 29 years male. Status post double bundle anterior cruciate ligament repair. The patient presented with discharging sinus in the proximal leg. A coronal proton density fat saturated (PDFS) image of the left knee shows a widened femoral track with the interference screw in the tibial track (yellow arrow). Adjacent altered marrow and soft tissue signal intensities suggest edema along the bio-absorbable screw.

Bioabsorbable screws are radiolucent and hence, it is the width of the track that must be followed. Any asymmetrical widening or loss of parallelism is indicative of loosening [Figure 8].^[8]

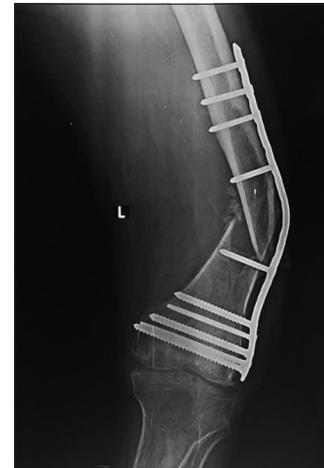
Figure 9: Anterior posterior radiograph of the femur showing a bent plate. During the initial phase of mobilization, the plates bear the load. Once the fracture gets “sticky” the bone starts to “share” the load. In the absence of a callus, the entire weight is taken by the plate, as seen in this case, leading to eventual failure.

Both nails and plates can also fail by bending or breaking. This is most often seen around areas of high strain concentration, such as a non-union, poor stability/early mobilization, or trauma leading to persistent or refracture [Figures 9 and 10].

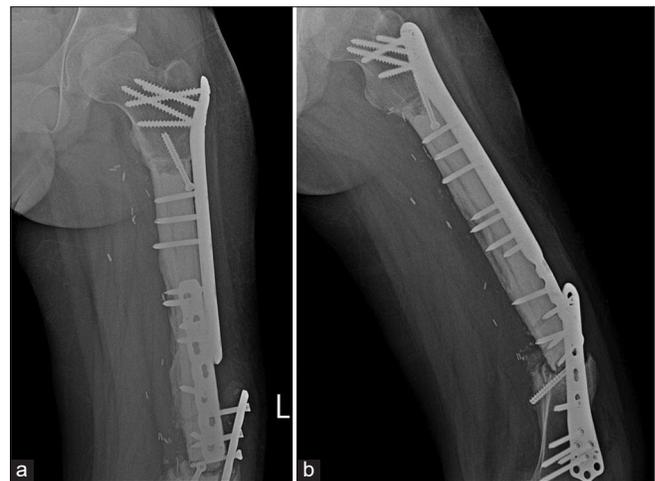
Figure 10: (a) Anterior posterior and (b) Lateral radiographs of the left thigh. Patient was a known case of Ewing's sarcoma with surgical excision, cement placement. Buttressing and compression plates are seen *in situ* with loosening of the plates and screws on the background of a non-united fracture. Patient did not follow directions and mobilized early. The patient was operated upon again and was asymptomatic on follow up.

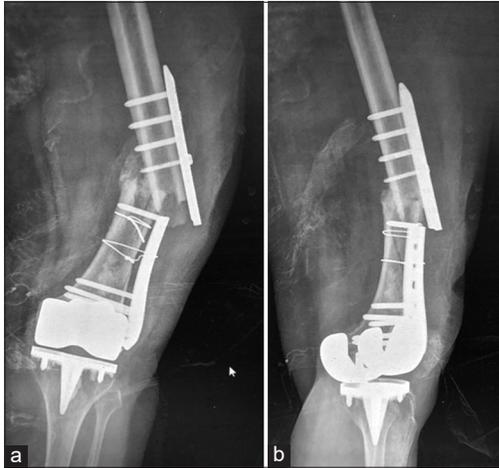
Figure 11: (a) Anterior posterior and (b) Lateral radiographs of the left thigh with knee. Morbidly obese patient, status post Total Knee Replacement (TKR) and diaphyseal fracture of the femur. Patient had a fall. Radiographs show intact knee prosthesis with a broken compression plate and refracture. See the beveled edges at the site of plate fracture, suggesting break at the screw hole.

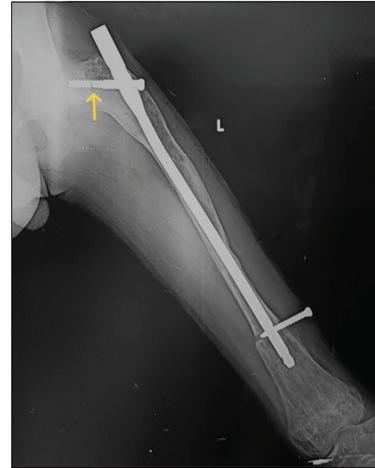
Figure 12: Anterior posterior radiograph of the left femur showing improper position of intramedullary nail-It is “proudly” (too proximal and outside the bone) placed with poor working length. Also, note the discontinuity in the proximal screw (yellow arrow) while the distal screw has backed out.

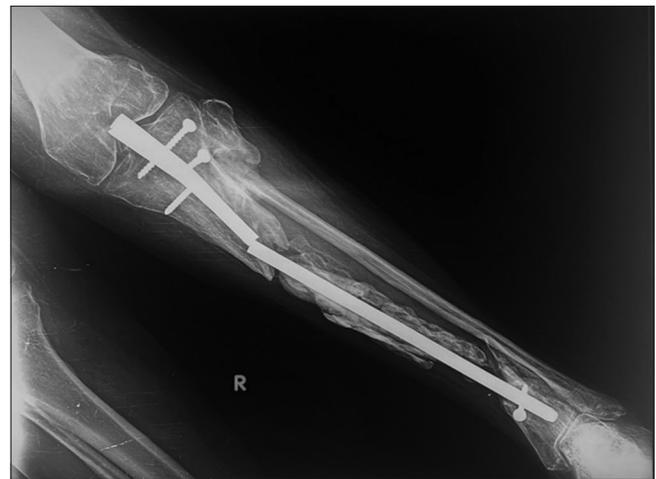
Figure 13: Anterior posterior radiograph of the leg with improperly positioned intramedullary (IM) nail with proximal end seen in the knee joint. There is non-union with sequestrum suggesting sequelae of infection. There is failure of the implant with fracture of the IM nail and proximal bolts.

Periprosthetic bony abnormalities suggesting infection are [Figures 13, 19, and 20]:^[14]

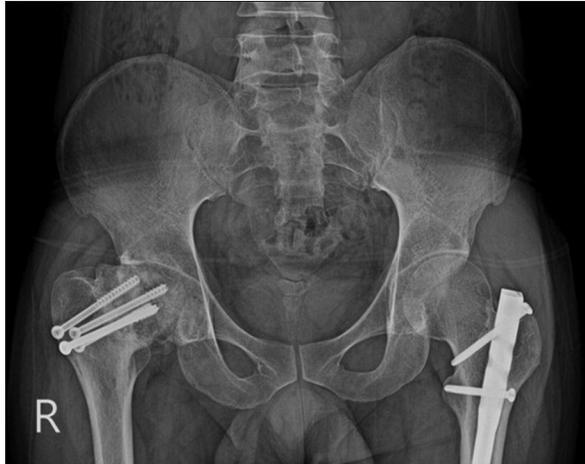
Figure 14: Anterior posterior radiograph of the pelvis. The patient was operated on for a fractured neck of the right femur with cannulated screws. The head is now collapsed with the loss of definition, consistent with avascular necrosis, which is a known complication. The radiologist needs to be aware of this complication and should look for it. Note is made of an intramedullary nail in the left femur, placed for femoral shaft fracture.

It is important to evaluate the immediate post-operative radiographs to assess any subsequent subtle changes in the position of the implants. Screw displacement is such an example, as they may migrate from their original position. Cannulated screws used to fix fracture neck of femur fractures may migrate within the neck or medially, crossing the joint space and compromising the blood supply leading to avascular necrosis (AVN) or causing acetabular damage with resultant secondary degenerative changes [Figure 14].

AVN requires special mention as an uncommon, but not unknown complication of surgical management of femoral neck fractures. As the findings may be delayed on conventional radiographs, a patient presenting with pain should be considered with a high index of clinical suspicion warranting an MRI [Figure 14].

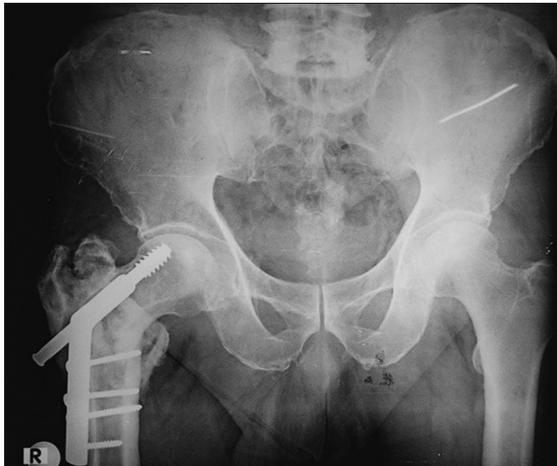
Figure 15: AP Radiograph of the pelvis with backed out dynamic hip screw. Note how the screw is displaced superiorly in the head of the femur.

Dynamic hip screws used in intertrochanteric fractures are also subject to loosening, migration, and fracture. There is also a minimal risk of compromised cortical blood supply secondary to the large surface area in contact with the cortex, risking delayed, or non-union [Figure 15].^[9]

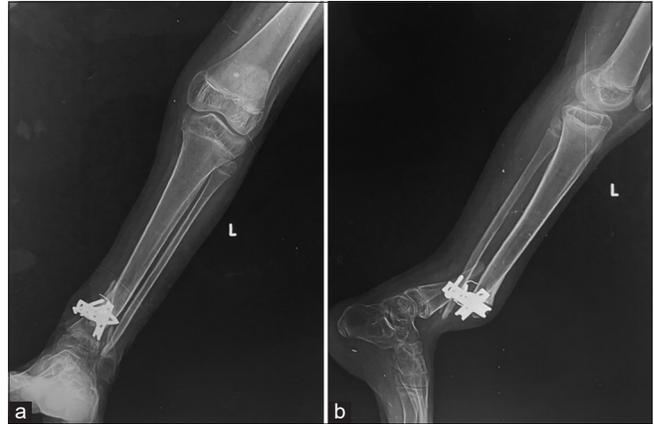
Figure 16: (a) Anterior posterior and (b) lateral radiographs of the leg showing fractures of the distal tibia and fibula, demonstrating poor fixation with only 2 screws on either side, leading to implant failure, from poor choice of the implant.

An implant may also fail if the appropriate hardware is not used or the placement uses poor technique [Figures 16-18].

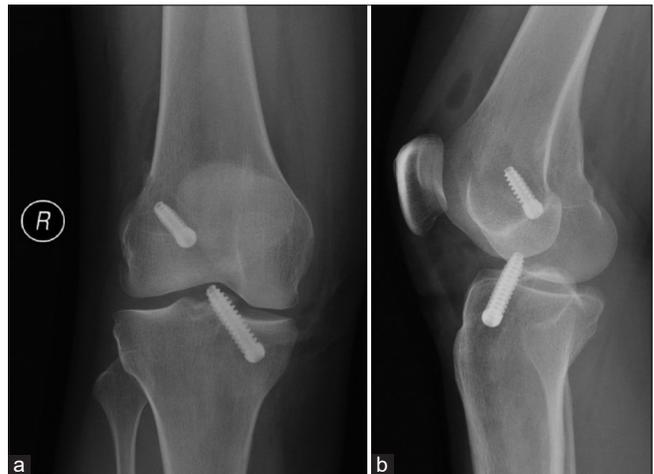
Figure 17: (a) Anterior posterior and (b) lateral knee radiographs taken immediately post-op (note the intra articular air) after anterior cruciate ligament reconstruction show unusually prominent tibial screw abutting the trochlear groove of the femur. (Image Courtesy Dr Raj Chari, Consultant Musculoskeletal Radiologist, Oxford University Hospitals NHS Trust).

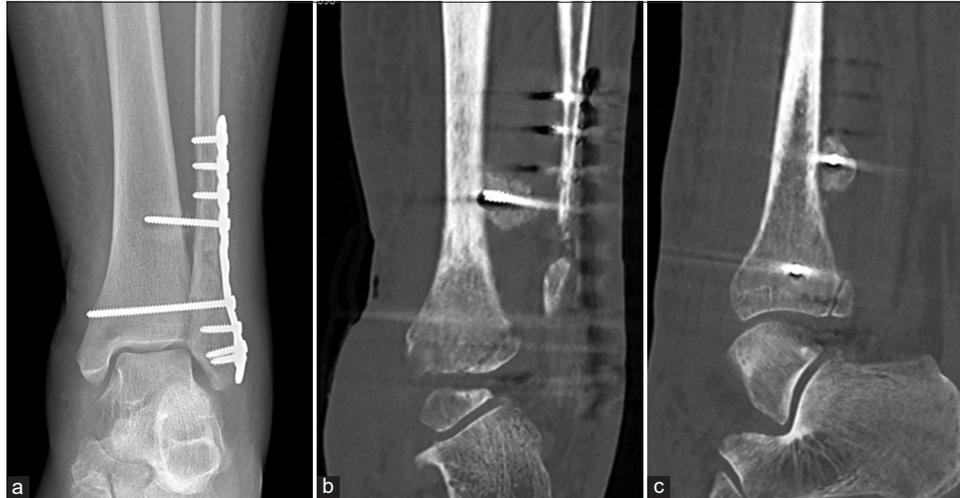
Figure 18: A 25-year-old man with increasing ankle pain following open reduction and internal fixation. (a) Anterior posterior radiograph of the ankle showing subtle lucency at the tip of the proximal tibia-fibula screw. It is unlikely to represent prosthetic loosening as the syndesmotomic screw does not show other signs of loosening. (b) Coronal and (c) sagittal CT reformatted images show that the screw tip is situated posterior to tibia instead of within the tibia. Note significant callus formation around the screw tip. (Image Courtesy Dr Raj Chari, Consultant Musculoskeletal Radiologist, Oxford University Hospitals NHS Trust).

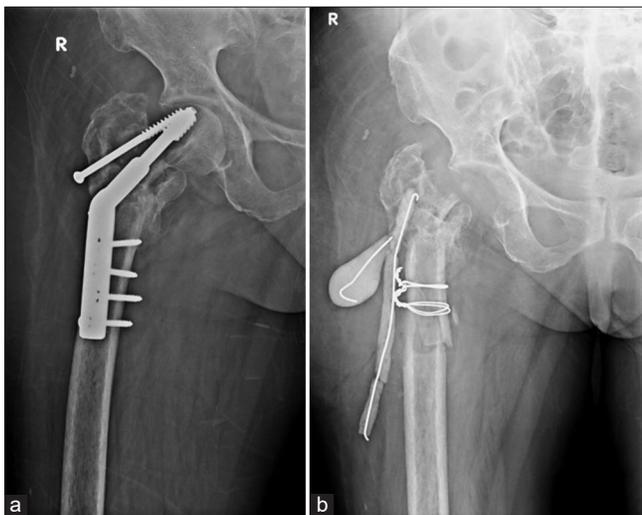
Figure 19: (a) Anterior posterior (AP) radiograph of the right hip show displaced dynamic hip screw with irregular lytic areas in the greater trochanter suspicious for infection. (b) AP view of the right hip, status post-surgical removal of the femoral head with placement of antibiotic laden K wires and cement. Cerclage wires were also placed for intra operative fracture of the shaft.

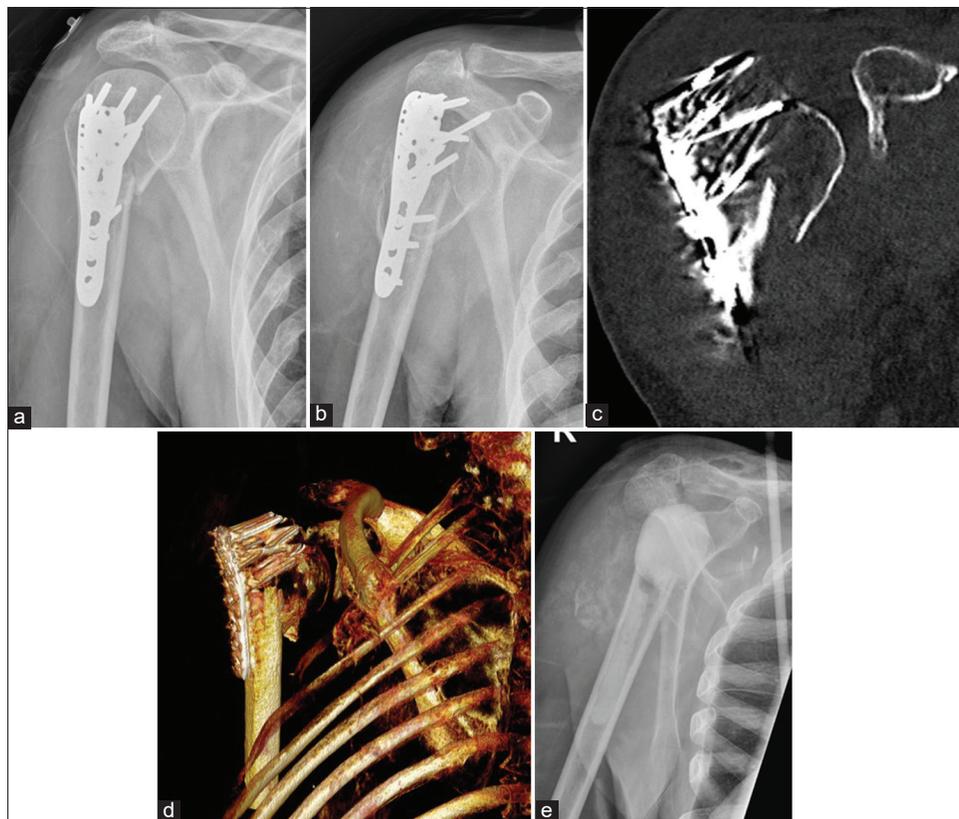
Figure 20: Anterior posterior radiographs of right shoulder taken 3 weeks apart (a) initial radiograph, (b) taken 3 weeks later, showing rapid destruction of the humeral head with exposed screws of the humeral internal fixation. Also note the multiple, old, rib fractures. (c and d), coronal and volume rendered CT images show exposed metal work and attenuation of the humeral head. (e) Post-operative Y view showing removal of metalwork and cement placement as a part of two stage replacement. (Image Courtesy Dr Raj Chari, Consultant Musculoskeletal Radiologist, Oxford University Hospitals NHS Trust).

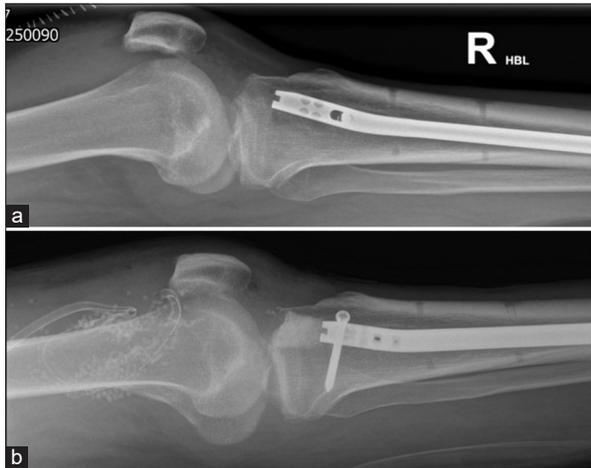
Figure 21: A 34-year-old man with a recent intramedullary nail fixation for a tibial fracture became acutely unwell within a week of his Surgery. (a) lateral knee radiograph on the 7th day shows large knee joint effusion which on aspiration grew Gram +ve cocci. (b) Lateral knee radiograph showing exchange of intramedullary nail, bone cement, intra articular antibiotic beads and surgical drain. (Image Courtesy Dr Raj Chari, Consultant Musculoskeletal Radiologist, Oxford University Hospitals NHS Trust).

Periprosthetic soft-tissue changes suggestive of infection are [Figure 21]:^[14]

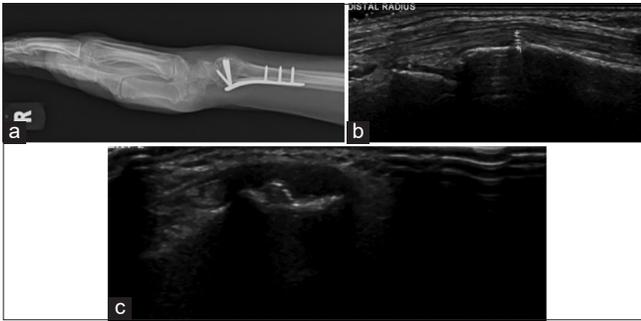
Figure 23: (a) Lateral radiograph of wrist showing plate and screw fixation. The distal row of screws was not seen to breach the cortex in the radiograph. (b and c) Longitudinal and transverse ultrasound images show a prominent screw tip adjacent to the Lister tubercle causing second extensor compartment tendinosis. (Image Courtesy Dr Raj Chari, Consultant Musculoskeletal Radiologist, Oxford University Hospitals NHS Trust).

It is a good imaging modality to examine the peri-implant soft tissues to identify collections or solid lesions like ALVAL. It can also be used to perform US-guided procedures for biopsies or aspirations [Figure 23].

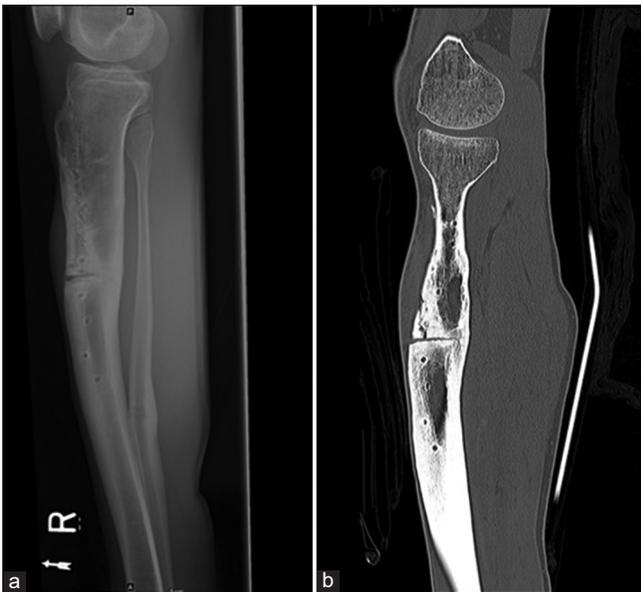
Figure 24: (a) Lateral radiograph of the leg shows non-union in the mid-shaft of the tibia with screw tracks from removed implants. An osteotomy was performed for the non-union. Also noted healed fracture of the distal shaft of the fibula. (b) Sagittal CT reformatted image shows a vertical fracture from the osteotomy which was not seen on the radiograph.

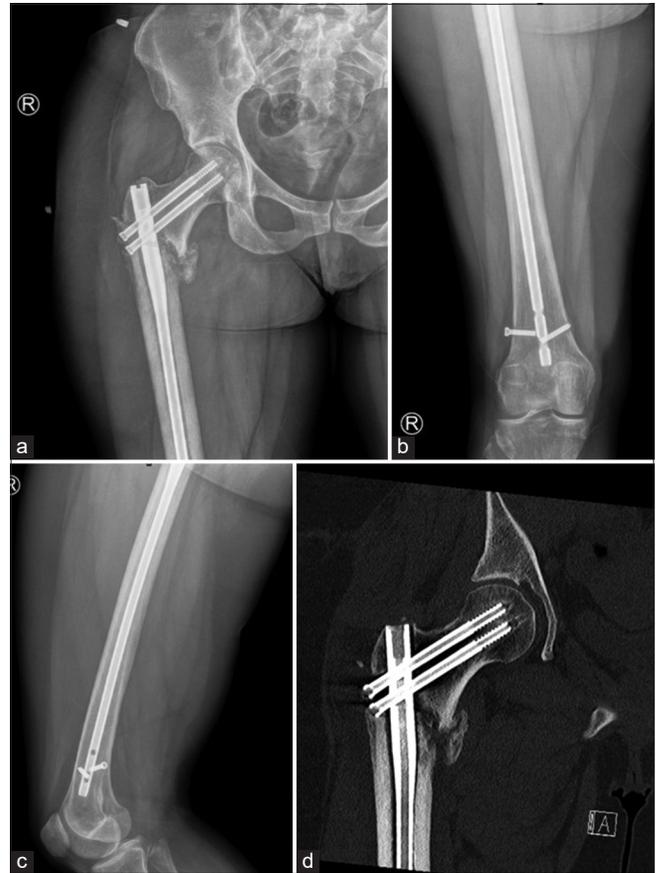
Figure 25: (a) Anterior posterior (AP) view of the right hip (b) AP view of the right thigh and (c) lateral view of the thigh shows lucency in the subtrochanteric region of the lateral femur from early loosening. Distal intramedullary rod- interlocking screw is broken with loosening. Also, the head of the distal of the two proximal screws is located within the fracture as shown in CT (d). Early loosening at the lateral subtrochanteric femur is confirmed on CT.

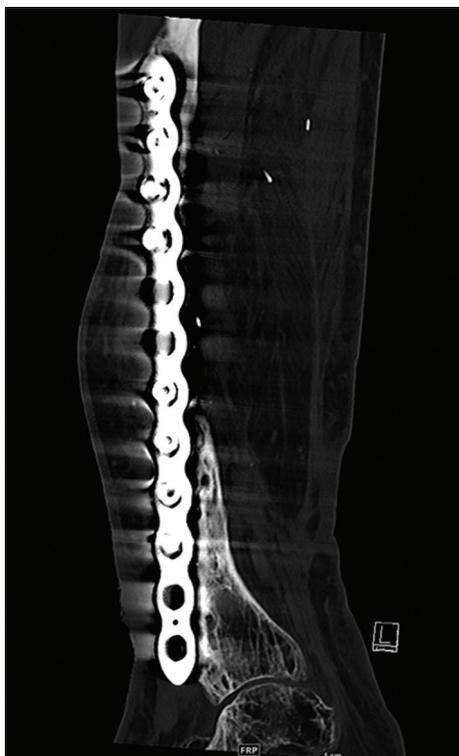
Figure 26: Sagittal CT reformatted radiographs of the tibia show a dynamic compression plate with backed out 3rd and 4th (counting from proximal) screws.

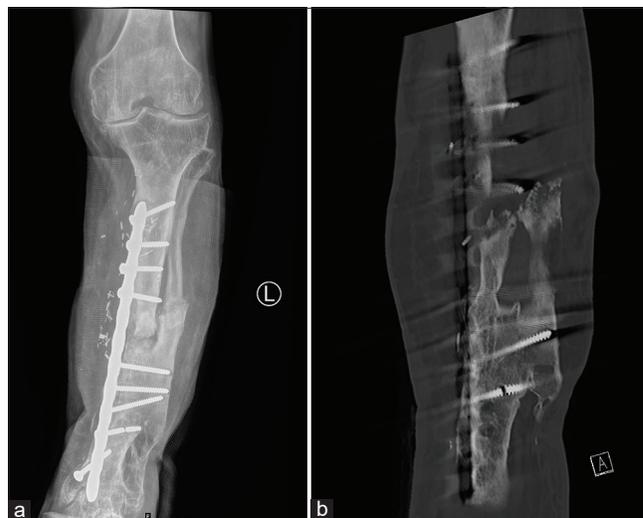
Figure 27: (a) Anterior posterior (AP) radiograph of the leg showing tibial and fibular fractures, dynamic compression plate and vascularized graft. Note that screw fracture was identified on both the radiograph and CT (b). The position of the screws is better seen within the new bone on CT due to reformats.

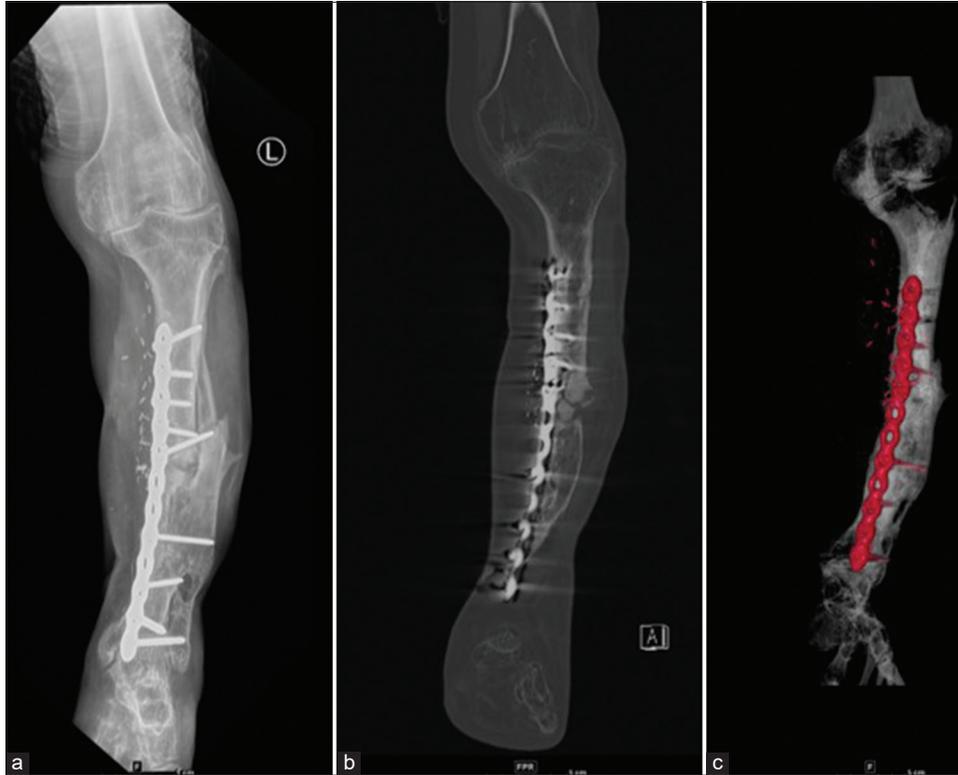
Figure 28: (a) Anterior posterior (AP) radiograph of the leg with (b) CT coronal and (c) 3D reformations with vascularized graft show break in the dynamic compression plate, proximal to the 5th screw (counted cephalic to caudal); Confirmed on CT reformats but sometimes as in this case, plain radiographs demonstrate hardware failure better. So always compare with plain radiographs.

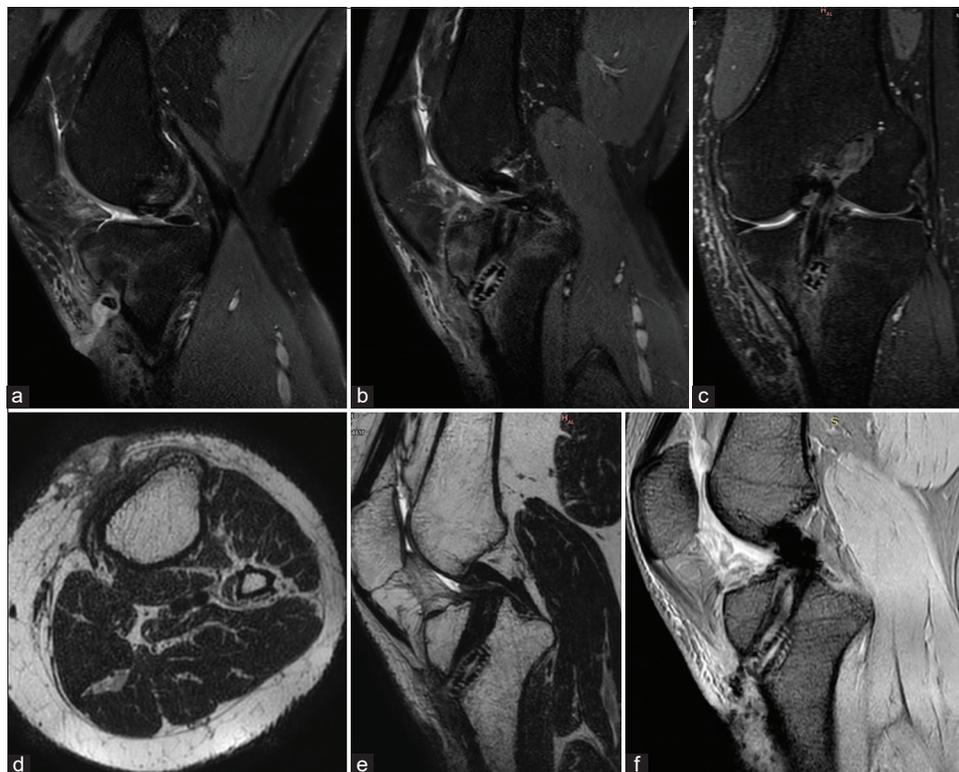
Figure 29: Same Patient as Image 8. Status post-double bundle anterior cruciate ligament repair. The patient presented with discharging sinus in the proximal leg. (a) Proton density fat-saturated sequence extreme sagittal and (b) midsagittal images show a hyperintense track in the soft tissues anterior to the tibia extending up to the dermis with marrow edema in the tibia. Soft-tissue edema is also seen in the soft tissues anteriorly and medially (c) on the coronal images. (d) Axial T2W image at the level of the tibia showing the track in the subcutaneous planes breaches the skin. (e) Corresponding Midsagittal T2W image. (f) Gradient echo sequences mid sagittal image showing foci of blooming in the intercondylar region and pretibial soft tissues.

MRI provides a better evaluation of the soft tissues, especially when assessing pseudotumors in metallosis, soft-tissue, marrow edema in infective etiology, and other soft-tissue lesions. The newer MARS sequences have increased the possibility of MRI applications.^[24] However, this modality is not generally used in routine practice with metallic implants. Foci of blooming are often seen along the tracks of the scope and at the hardware site. It is, however, frequently used to evaluate postoperative anterior cruciate ligament repair complications [Figure 29].
